国宝・重要文化財建造物の蟻害緊急調査 千葉県蟻害調査を中心に

国宝・重要文化財建造物の蟻害緊急調査

—千葉県蟻害調査を中心に—

森 八郎*・新井英夫・町田和江*

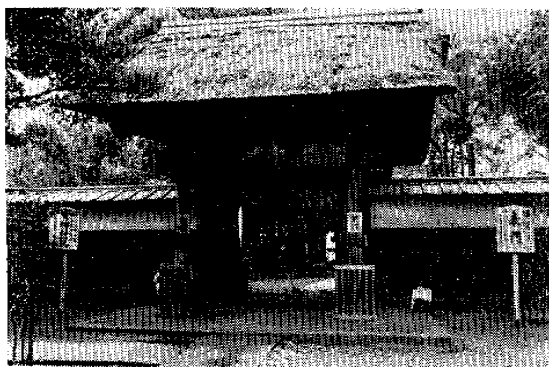
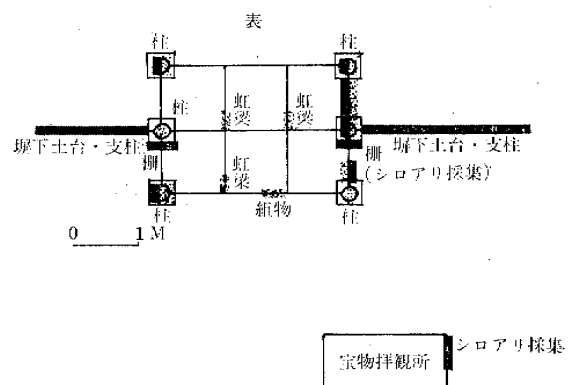
図—1—(a) 床 上

立地条件：神野寺表門は、房総第一の高山・鹿野山上のうっそうたる樹木にとり囲まれた場所にあつて、かなり多湿状態と認められるので、シロアリの生息に好適と考えられる環境である。

蟻 害：あり、やや大、軸部、ヤマトシロアリ。柵より多数の幼虫・職蟻を採集したので、この近くに営巣しているものとみなされた。

付近の蟻害：宝物拝観所に蟻害が認められ、多数のヤマトシロアリを採集した。

その他の虫害：キクイムシの被害もやや大。

- (1) 神野寺表門：ヤマトシロアリが生息加害中であり、キクイムシの被害もあるので、被覆燻蒸を行ない、その後で防蟻剤の吹付処理と土壌処理を実施する必要がある。
- (2) 石堂寺本堂：解体修理が望ましいが、昭和41年に屋根換えをしているので、今実施するのは無理と思われる。現時点では、被覆燻蒸が最も有効である。最少限床下部材の吹付・穿孔・土壌処理が必要である。

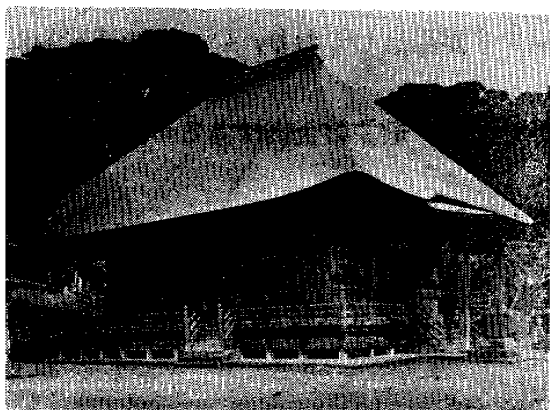
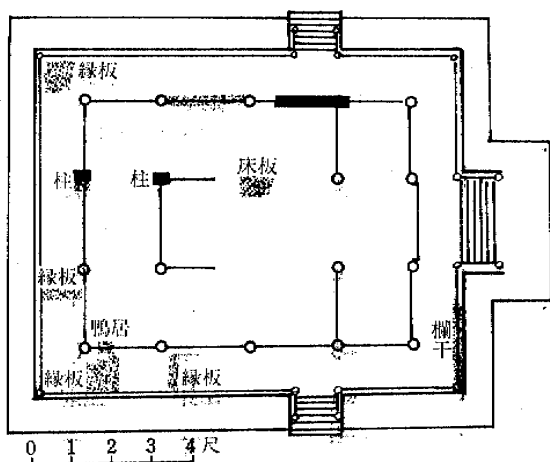
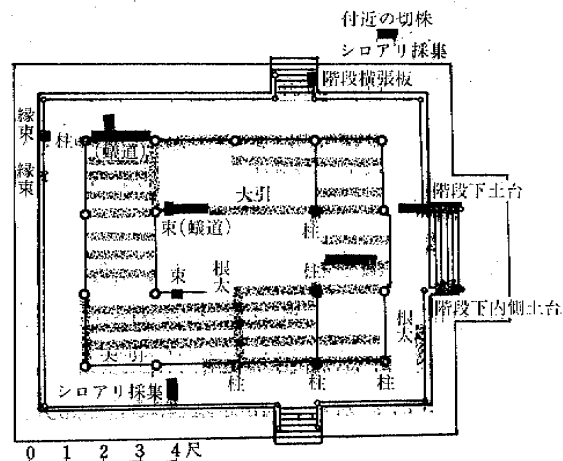
図-2-(a) 床 上

立地条件：石堂寺本堂は、高い石段の上であって、その建物は、背面にうっそうたる樹木をひかえ、非常に温暖多湿で、シロアリの繁殖に好適な条件を備えた環境である。

蟻害：あり、やや大、土台・床廻り・軸部、ヤマトシロアリ。蟻道が構築されており、床下に放置された木材に多数のヤマトシロアリの幼虫・職蟻が生息加害していたので、この建物のどこかに巣があるものとみなされた。

付近の蟻害：太子堂・多宝塔・庫裡の蟻害甚太。

その他の虫害：キクイムシの被害も甚大。

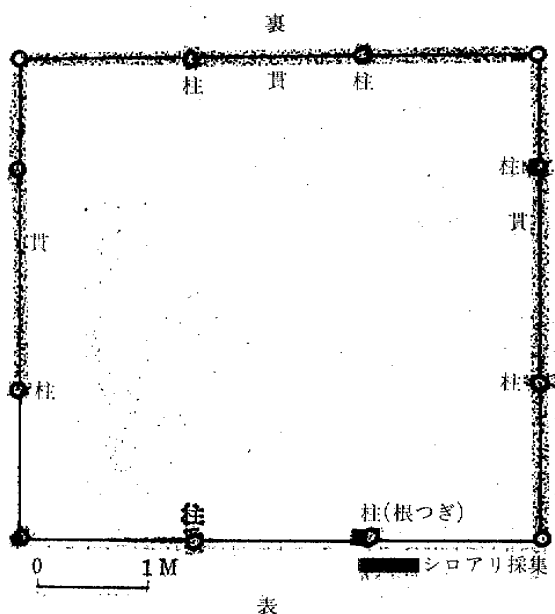
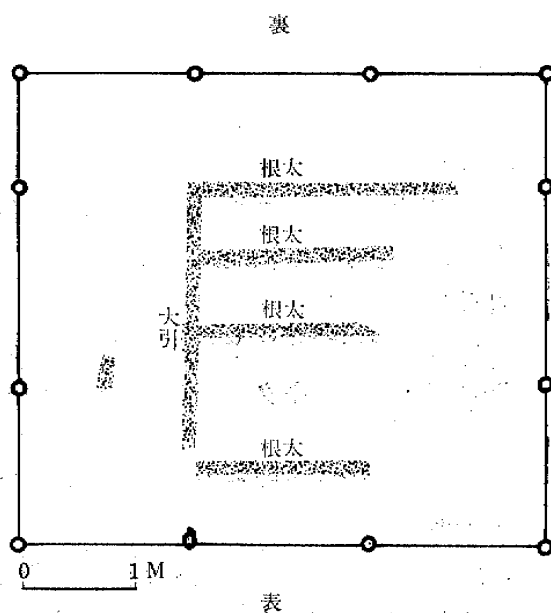
図-3-(a) 床 上

立地条件：石堂寺薬師堂は、うっそうたる樹木を切り開いて移築したようで、三方を大木に囲まれ、現在その立木・伐根にはヤマトシロアリが生息しており、いつこの建造物に侵入するかわからない危険な環境である。

蟻害：なし。解体修理の際、古材を使用しているので、過去の食痕はあるが、現在蟻害なし。

付近の蟻害：付属建物はないが、周囲の立木よりヤマトシロアリを採集した。

その他の虫害：キクイムシの被害が認められた。

防蟻処理：昭和49年に解体修理の際、アリアンチ・アリデン（三共 K.K.）による防蟻処理をしており、効果は確実と認められた。

- (3) 石堂寺薬師堂：キクイムシ被害が認められるから、一度被覆燻蒸を実施するとよい。蟻害に関しては、解体修理にあたって防蟻処理を行っており、まだ数年以上有効と認められる。しかし、その後は予防の意味で床下部材に防蟻剤の吹付・土壌処理が必要である。
- (4) 大聖寺不動堂：キクイムシの被害があるので、一度被覆燻蒸を実施し、その後で防蟻剤の吹付・土壌処理を行なうとよい。この処置ができない場合は、床下部材の吹付・穿孔・土壌処理を実施すべきである。

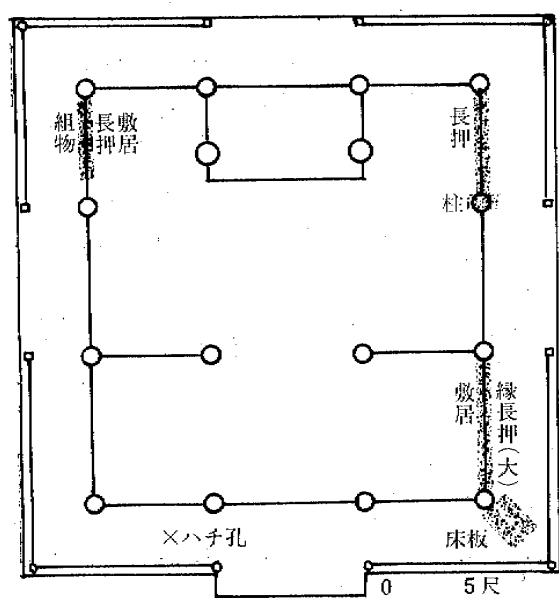
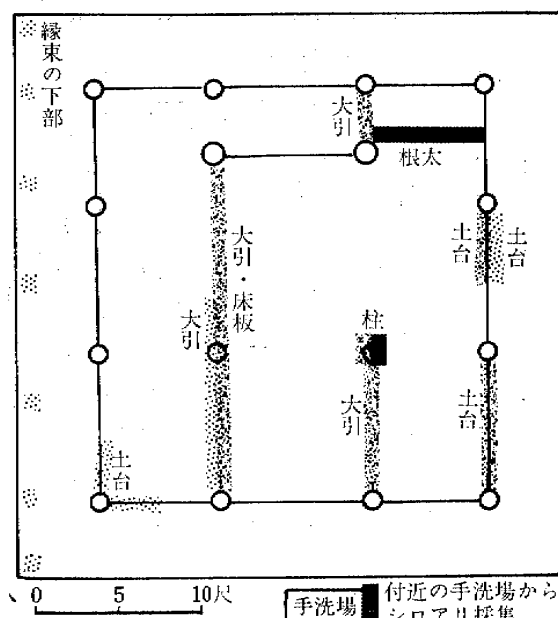
図-4-(a) 床 上

立地条件：海岸から近い眺望のきく、高丘に建立されているが、給水源が近いので、かなり多湿で、シロアリにとっては中程度の好適な環境である。

蟻害：あり、中程度、土台・床廻り・軸部、ヤマトシロアリ。

付近の蟻害：付属建物はないが、付近の手洗場からヤマトシロアリを採集した。防風のための衝立の支柱にヤマトシロアリの食痕が認められた。

その他の虫害：キクイムシの被害もやや大。

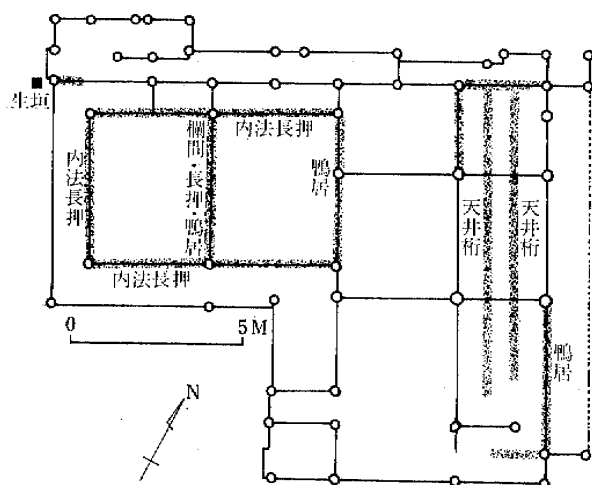
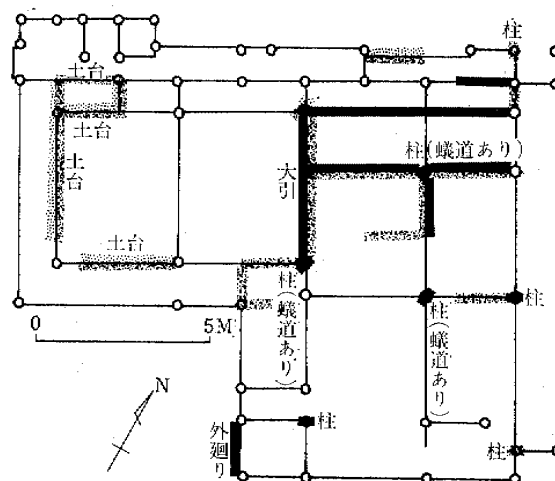
図-5-(a) 床 上

立地条件：渡辺家は、軍用金御用達をつとめた家柄の商家で、その住宅は街道に面した普通の民家のため、神社・仏閣の建物と比較すると、床下が低いので、床下に細かい砂を入れているが、それでもシロアリの繁殖しやすい環境である。

蟻害：あり、甚大、土台・床廻り・軸部、ヤマトシロアリ。文化財であるので、被害材

を壊すことができず、巣の探知は無理であるが、営巣していることは確実である。

付近の蟻害：庭の立木・生垣などにヤマトシロアリが生息していた。

その他の虫害：キクイムシの被害も甚大。

- (5) 渡辺家住宅：キクイムシの被害も甚大であるので、密閉燻蒸を実施したいが、数日間家族の立退きが前提条件となる。これができない場合は、床上に DDVP 樹脂蒸散剤を使用し、床下は防蟻剤の吹付・穿孔・土壌処理を実施する。
- (6) 笠森寺観音堂：DDVP 樹脂蒸散剤の使用と、防蟻剤の吹付処理を行なう。

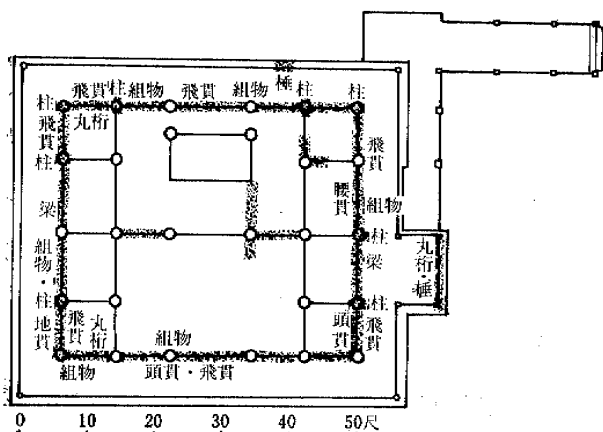
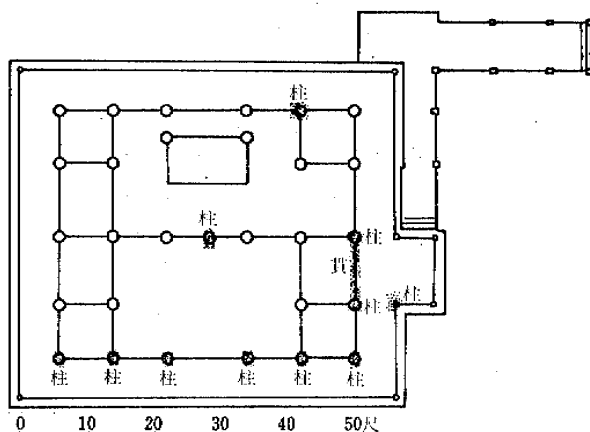
図-6-(a) 床 上

立地条件：山頂の巨岩上に建立されており、いわゆる「懸け造り」で通風がよく、蟻害を受けにくい環境である。

蟻害：なし。

付近の蟻害：なし。

その他の虫害：キクイムシの被害は甚大。

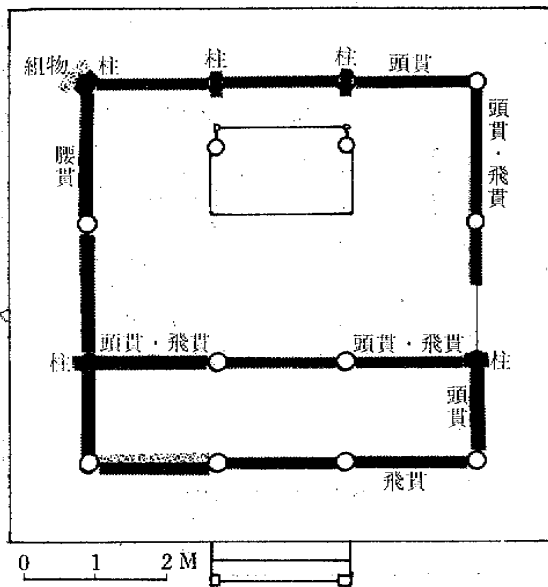
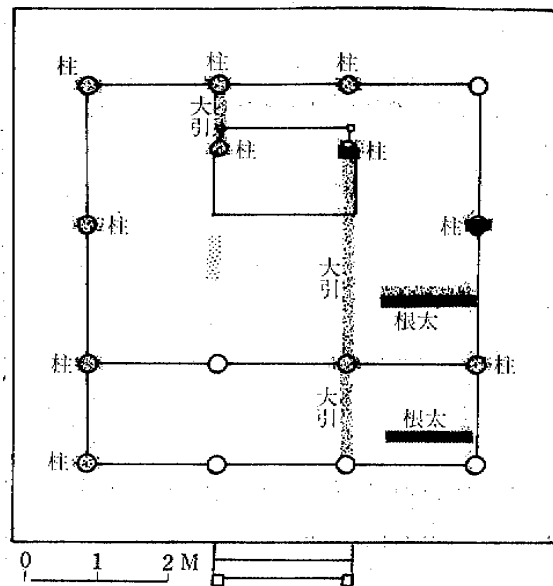
図-9-(a) 床 上

その他の虫害：キクイムシの被害もやや大。

- (7) 西願寺阿弥陀堂：予防の意味で、床下部材に防蟻剤の吹付・土壌処理を行なう。
- (8) 鳳来寺観音堂：予防の意味で、床下部材に防蟻剤の吹付・土壌処理を実施する。
- (9) 栄福寺薬師堂：被覆燻蒸を行ない、その後で、床下部材に防蟻剤の吹付・土壌処理を実施する。
- (10) 竜正院仁王門：キクイムシの被害が甚大であるので、一度被覆燻蒸を行ない、その後で防蟻剤の吹付・土壌処理を実施する。

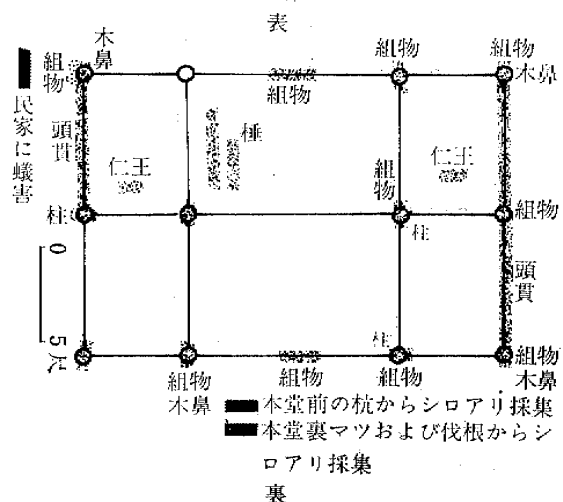
図-10-(a) 床 上

立地条件：日当たりのよい平地に建立されているために、蟻害を防ぐ環境となっている。

蟻害：なし。

付近の蟻害：仁王門の付属建物はないが、近くの民家の蟻害は甚大であった。本堂前の杭および本堂裏のマツ立木・伐根がヤマトシロアリの巣となっていた。ここでヤマトシロアリを採集した。

その他の虫害：キクイムシの被害は甚大。

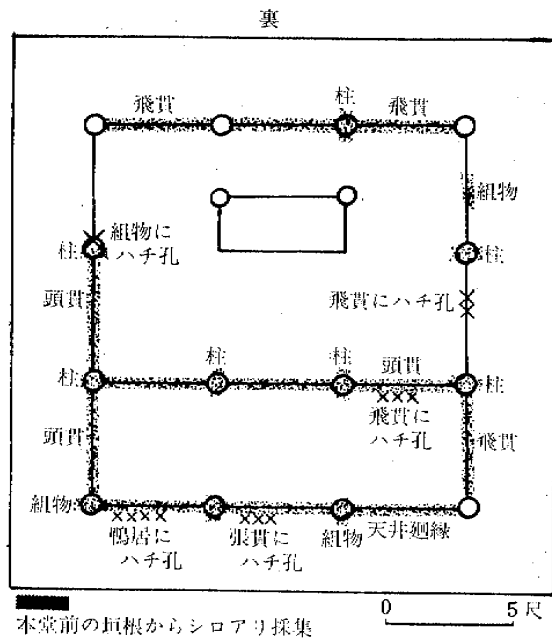
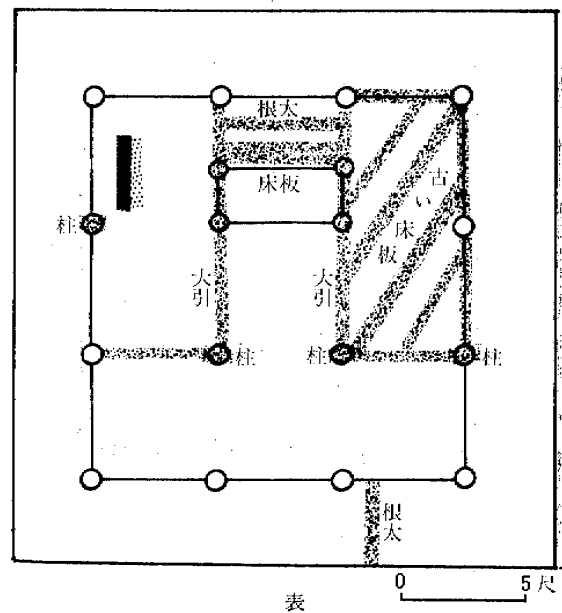
図-11-(a) 床 上

立地条件：丘陵上にあり、うっそうたる巨木に囲まれているため多湿であり、蟻害を受けやすい状態であるが、床下の通風がよいので、そのわりに防蟻効果のある環境である。

蟻害：あり、やや軽微、土台・床廻り、ヤマトシロアリ。

付近の蟻害：付属建物はない。本堂前面の柵は、殆んどすべて蟻害進行中で、ここからヤマトシロアリを採集した。

その他の虫害：キクイムシの被害は甚大。

- (11) 宝珠院観音堂：キクイムシの被害も甚大であるから、一度被覆燻蒸を行ない、その後で防蟻剤の吹付・土壌処理を実施する。
- (12) 滝田家住宅：解体修理が必要である。その際に、建築用材の浸漬処理を行ない、再建にあたっては、土壌処理を入念に実施する。
- (13) 法華経寺四足門：防蟻剤の吹付処理程度でよい。

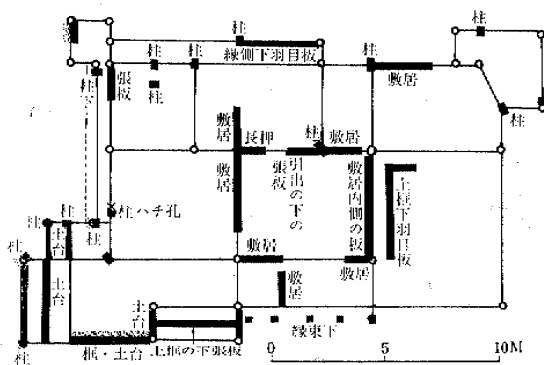
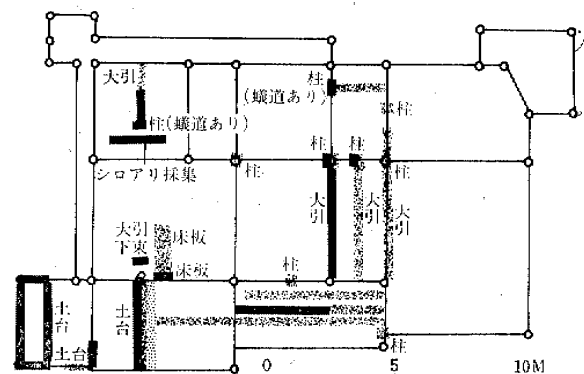
図-12-(a) 床 上

立地条件：名主をつとめた家柄の大農家であるが、神社・仏閣と比較して、床下がきわめて低く、通風悪く、最も蟻害のおこりやすい環境である。

蟻害：あり，甚大，縁廻り・土台・床廻り・軸部，ヤマトシロアリ。今回の調査の建造物中では最大の蟻害を受けていた。東石に蟻道があり，この中をシロアリが往来していた。床下からヤマトシロアリを採集した。

付近の蟻害：接続建物の蟻害も甚大。

その他の虫害：キクイムシの被害も甚大。

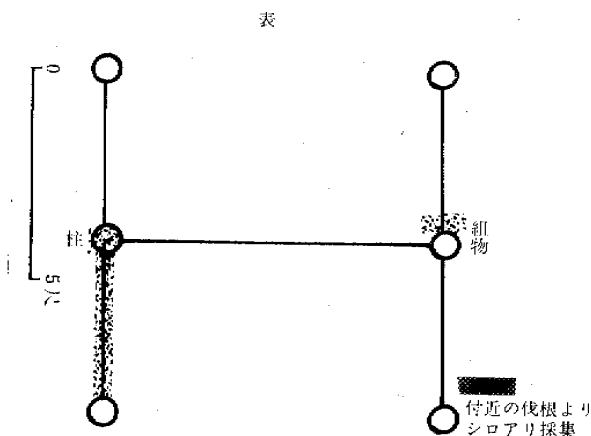
図-13-(a) 床 上

立地条件：高い石段を登った上にあり，日当たりよく，比較的乾燥しているので，蟻害を防ぐ環境である。

蟻害：なし。

付近の蟻害：法華堂床下に蟻害が認められた。また，付近の伐根よりヤマトシロアリを採集した。

その他の虫害：キクイムシの食痕も若干あるが，軽微で，過去のものと思われた。

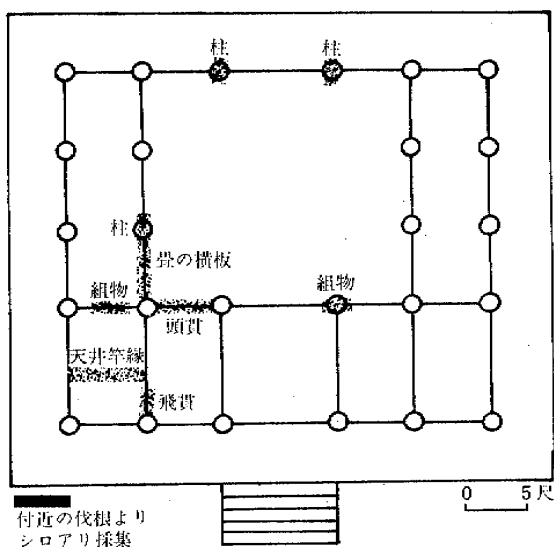
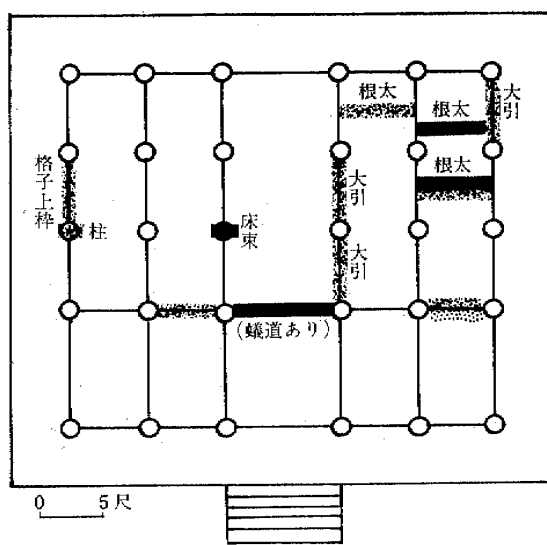
図-14-(a) 床 上

立地条件：石段を登った比較的高所に建立されているが、周囲に樹木をひかえ、わりに多湿であるので、シロアリにとっては中程度の環境である。

蟻害：あり、中程度、土台・床廻り・軸部、ヤマトシロアリ。

付近の蟻害：四足門には蟻害はないが、付近の伐根よりヤマトシロアリを採集した。

その他の虫害：キクイムシの被害も中程度であった。

- (14) 法華経寺法華堂：床下部材の穿孔・吹付・土壌処理、床上は DDVP 樹脂蒸散剤を使用する。
- (15) 法華経寺五重塔：床下部材の穿孔・吹付・土壌処理、床上は DDVP 樹脂蒸散剤を使用する。
- (16) 飯香岡八幡宮本殿：キクイムシの生息が認められたから、燻蒸処理が最も有効であるが、規模がかなり大きくなるので、第一手段として、DDVP 樹脂蒸散剤の使用と防蟻剤の吹付処理を勧めたい。また、雨の降込みもあり、防腐処理も必要である。

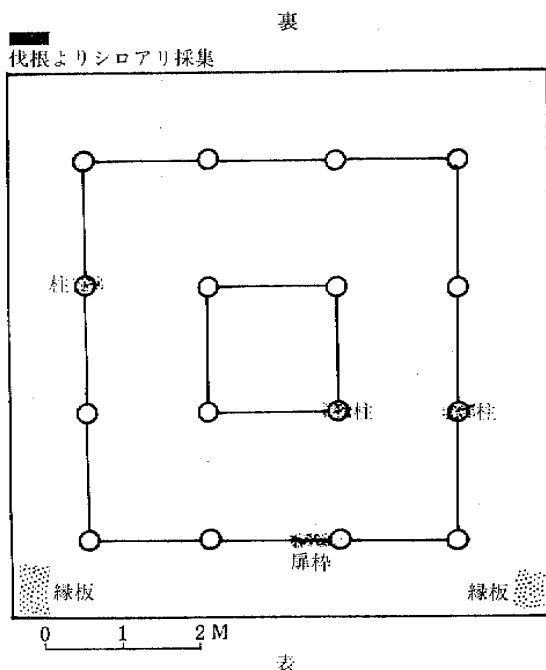
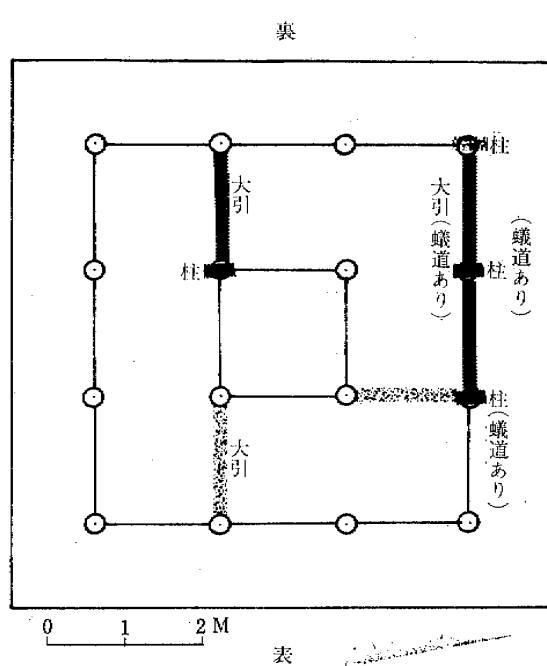
図-15-(a) 床 上

立地条件：境内のなかでは比較の日当たりのよいところに建立されているが、左右、背面に樹木をひかえているため、シロアリの侵入しやすい環境である。

蟻害：あり、やや大、土台・床廻り・軸部、ヤマトシロアリ。この建物中に営巣していることは確実である。

付近の蟻害：付属建物はないが、五重塔裏の伐根よりヤマトシロアリを採集した。

その他の虫害：キクイムシの被害も認められたが、大したことはない。

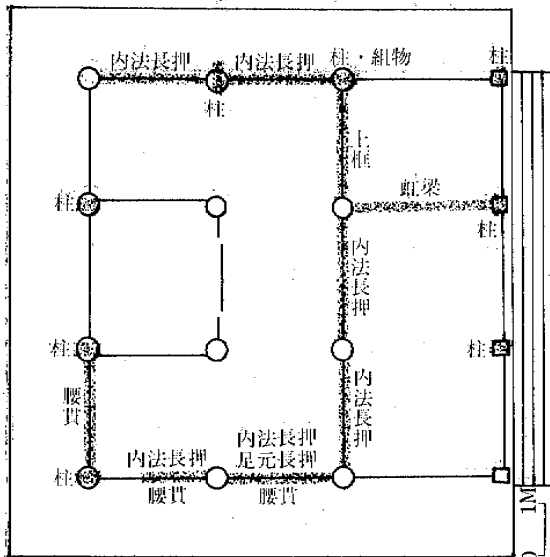
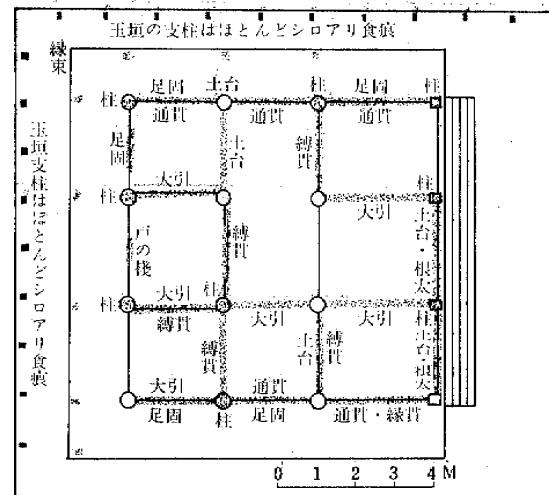
図-16-(a) 床 上

立地条件：砂質の非常に乾燥した平地に建立されているので、防蟻効果のよい環境である。

蟻害：なし。

付近の蟻害：周囲の玉垣の支柱のほとんど全部に蟻害と腐朽が認められたが、調査当日は、土壌が非常に乾燥していたため、シロアリは採集できなかった。本殿裏の支柱にも蟻害が認められた。

その他の虫害：解体修理に際し、なるべく古材を使用したため、キクイムシの食痕はかなり多かった。

防蟻処理：昭和43年修理の際に、キシラモン（武田薬品工業 K. K.）による塗布，土壌処理を施工しており，効果は「やや確実」である。
